Test Report No.: SHAEC25001366805 **Date**: Jun 12, 2025 Page 1 of 4

Sample Name: semiconductor device

Model No.: LL-34

Halogen

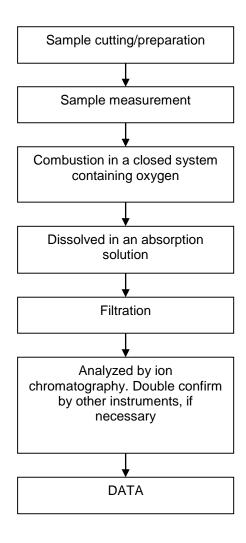
Halogen Testing Flow Chart

Test Method: With reference to EN 14582:2016, analysis was performed by IC.

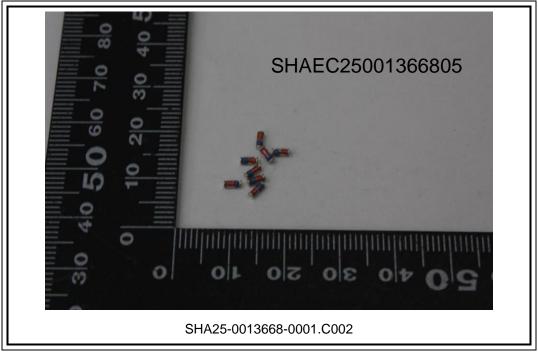
Sample Photo:

SN ID	Sample No.	SGS Sample ID	Description
SN1	A2	SHA25-0000408-0001.C002	Copper body with silvery metal
